## Concrete Supply Company – Mauldin Plant

### Unpermitted Industrial Stormwater Inspection SC

December 11, 2018

SW-CSCMauldin-12/11/18

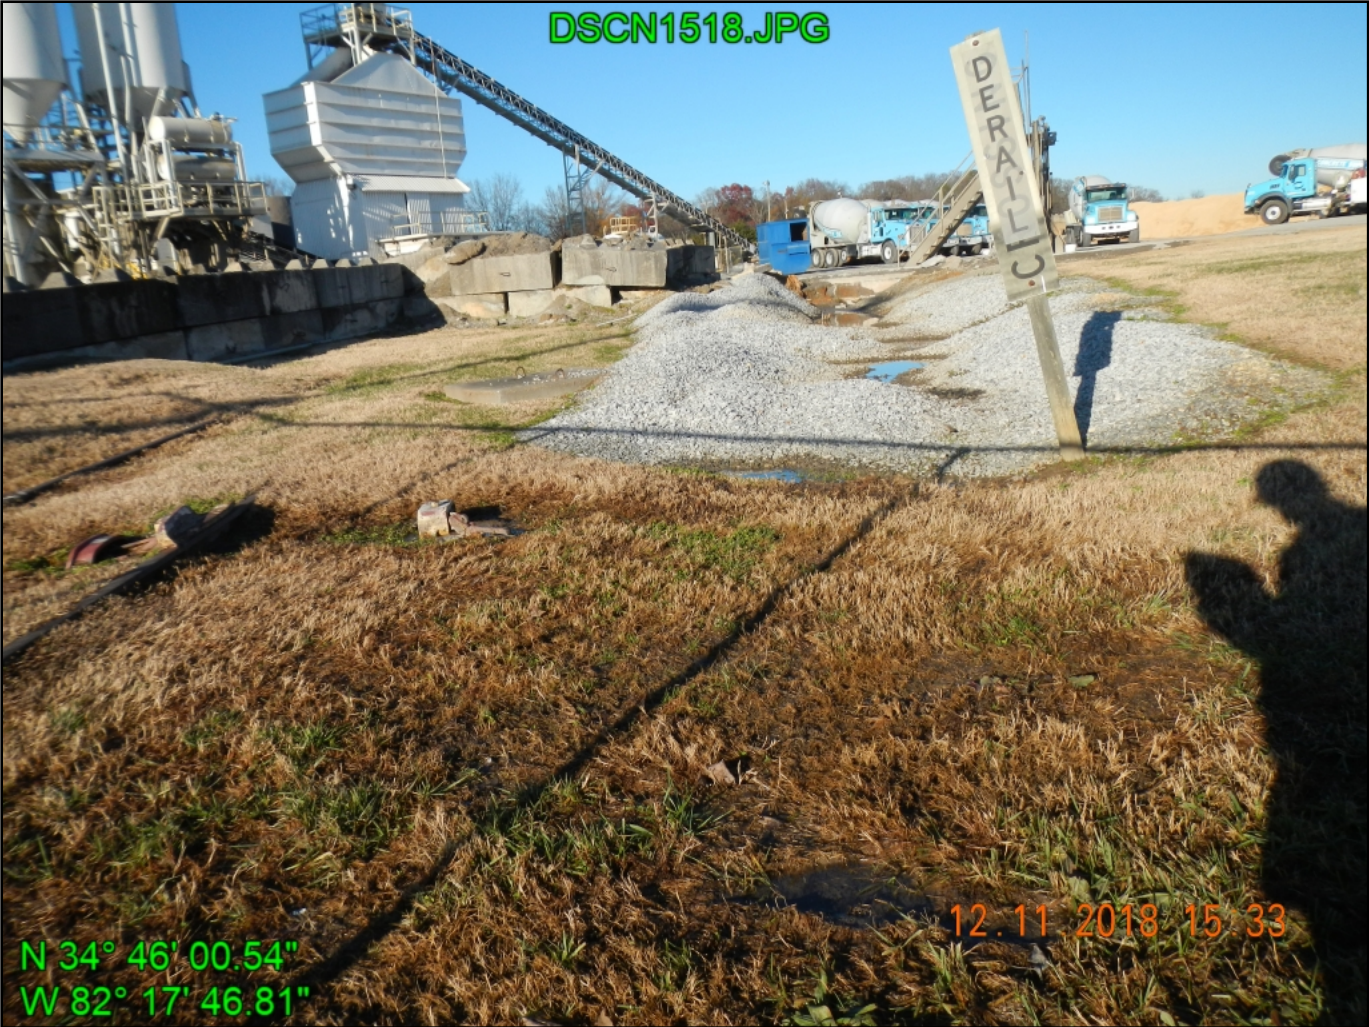
Attributes	
Description	Stormwater Outfall #2. Water flows southwesterly, towards photographer.

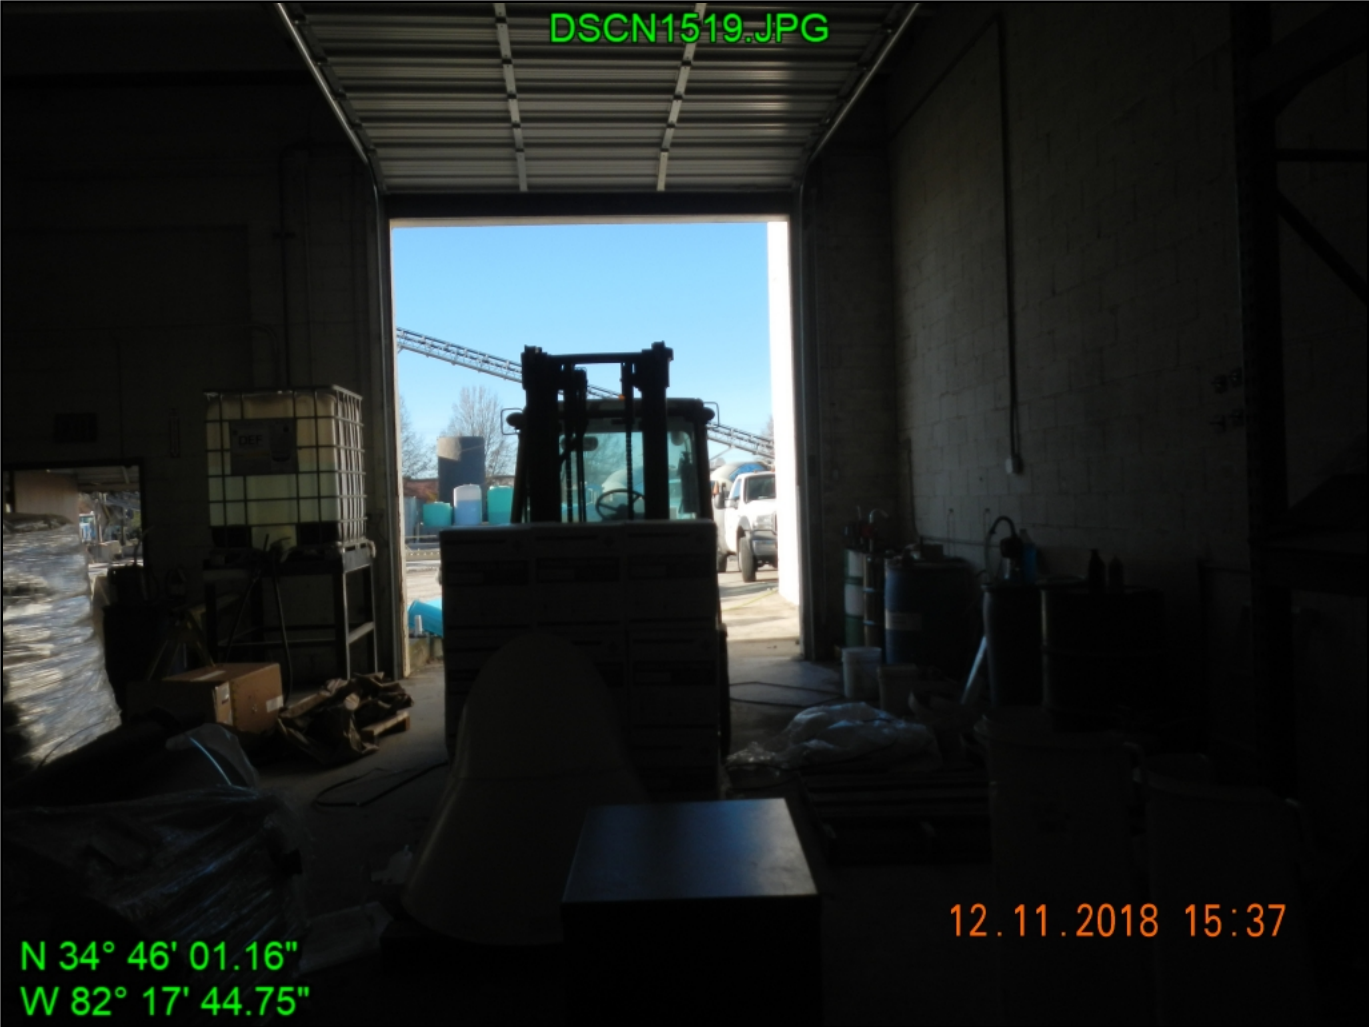
Attributes	
Description	Fluids for truck maintenance and other materials are stored in this building.

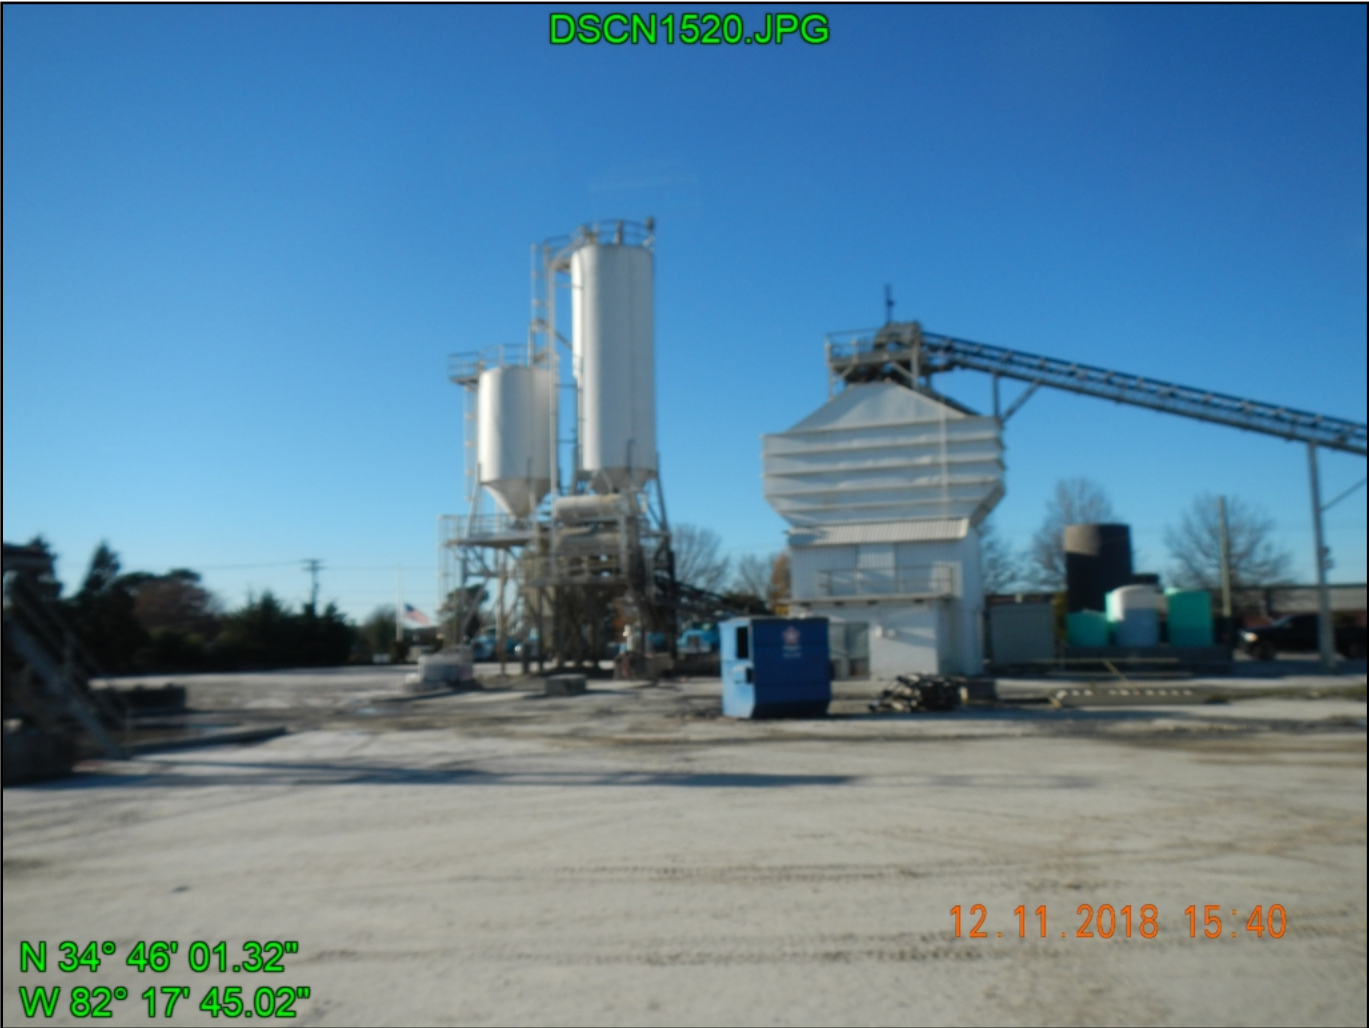
Attributes	
Description	Mixing and dispensing facilities - the tote at the left serves the truck wash station and the tanks center-right are liquids ad-mixes for various concrete mixes.

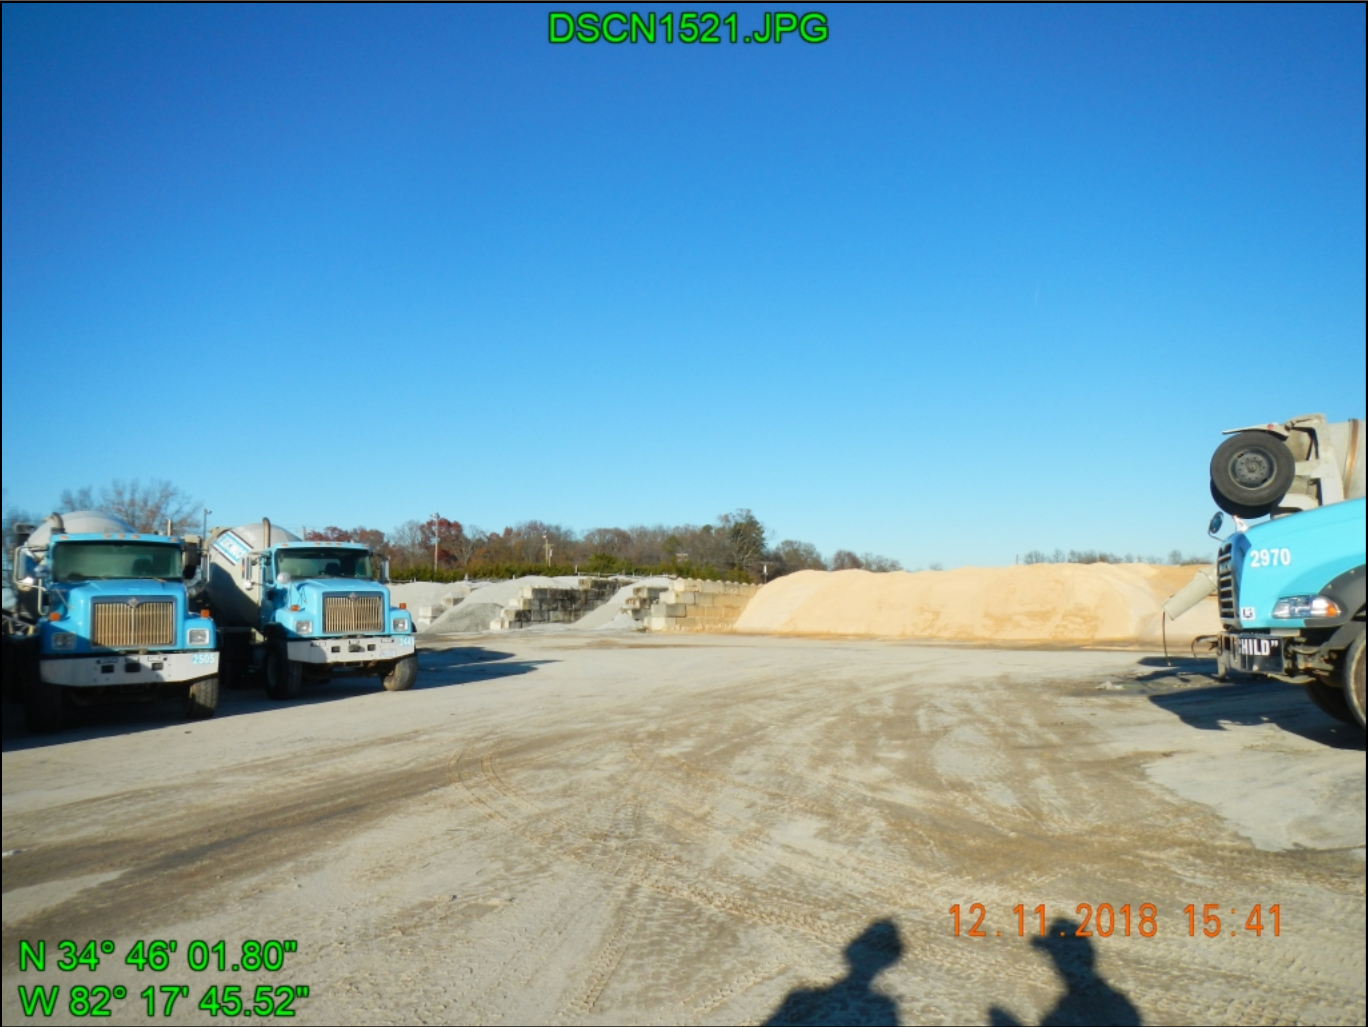
Attributes	
Description	Sand and other piles are exposed to rainwater.

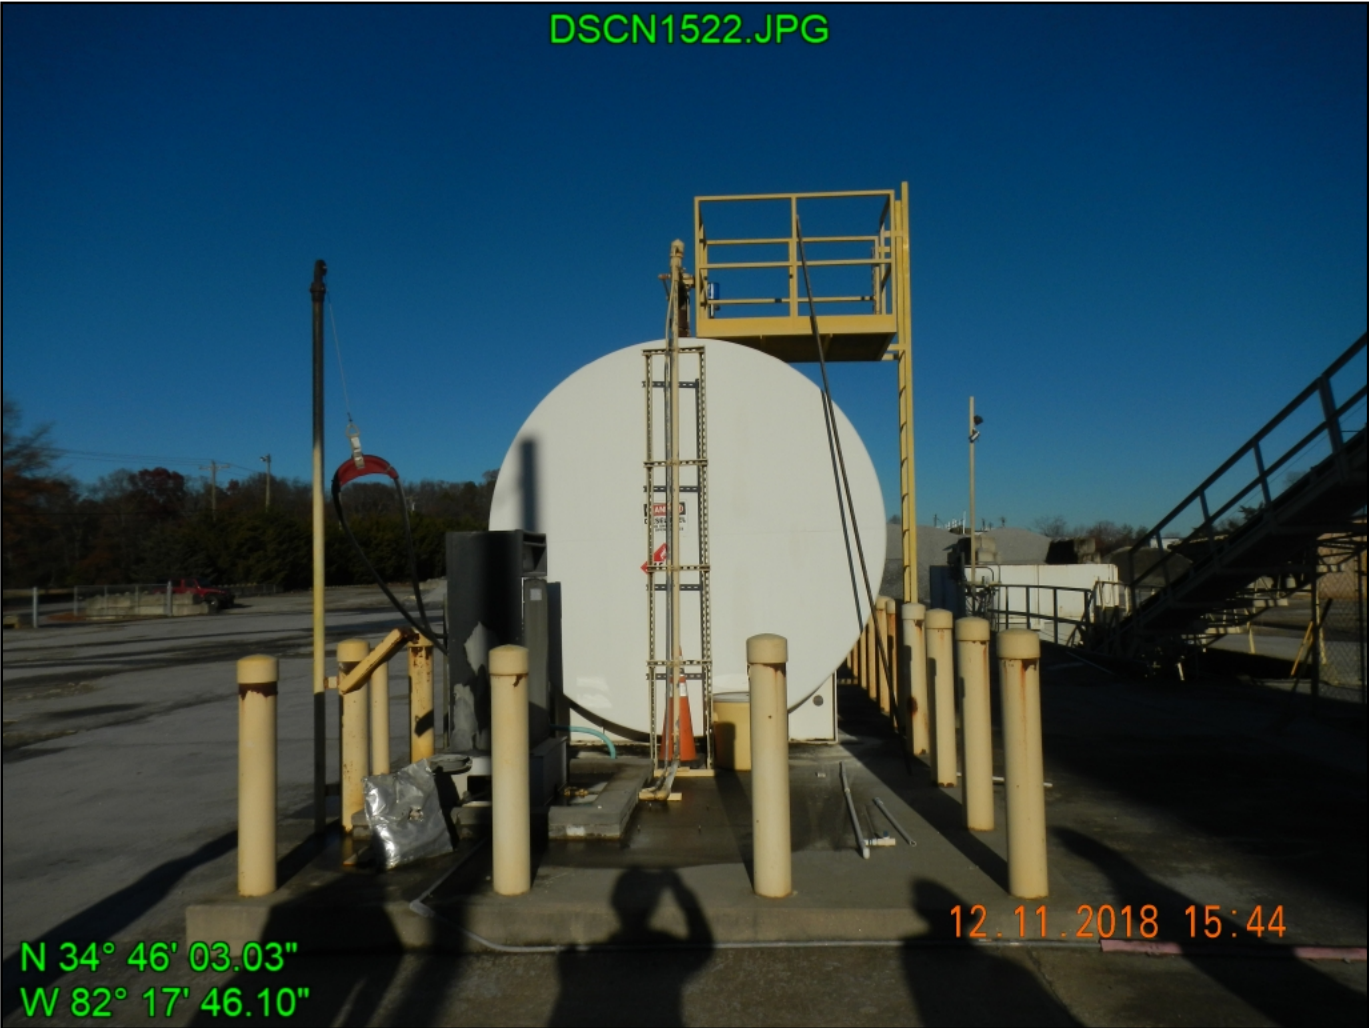
Attributes	
Description	Diesel fill station - double walled fuel tank with bollards and filling plumbing.

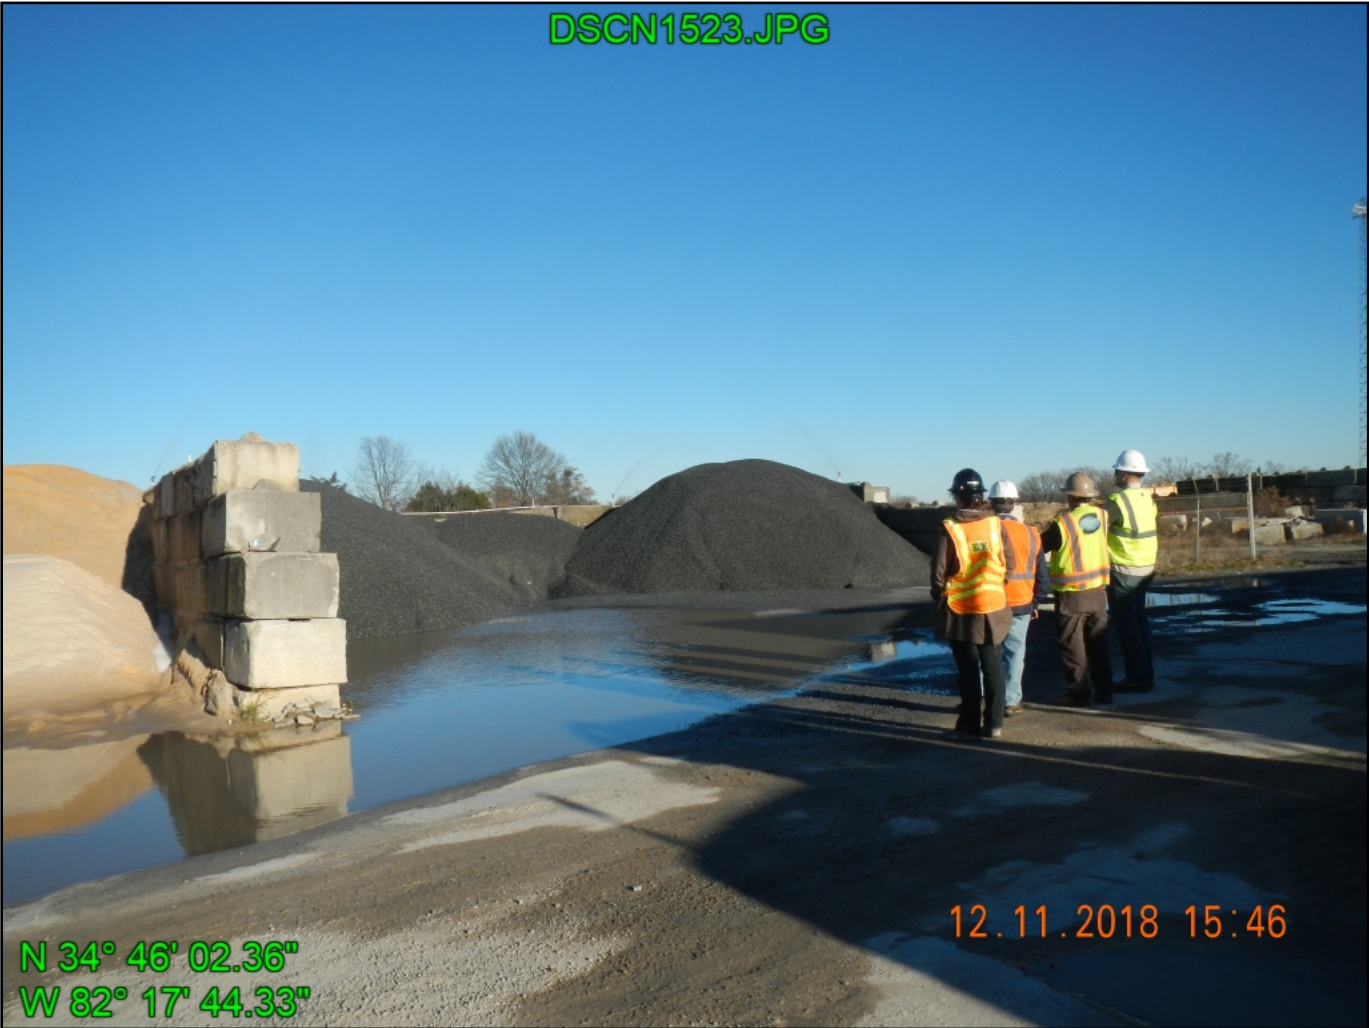
DSCN1524.JPG

Attributes	
Description	Pile of light weight aggregate. This pile is sprayed with municipal water through sprinklers.

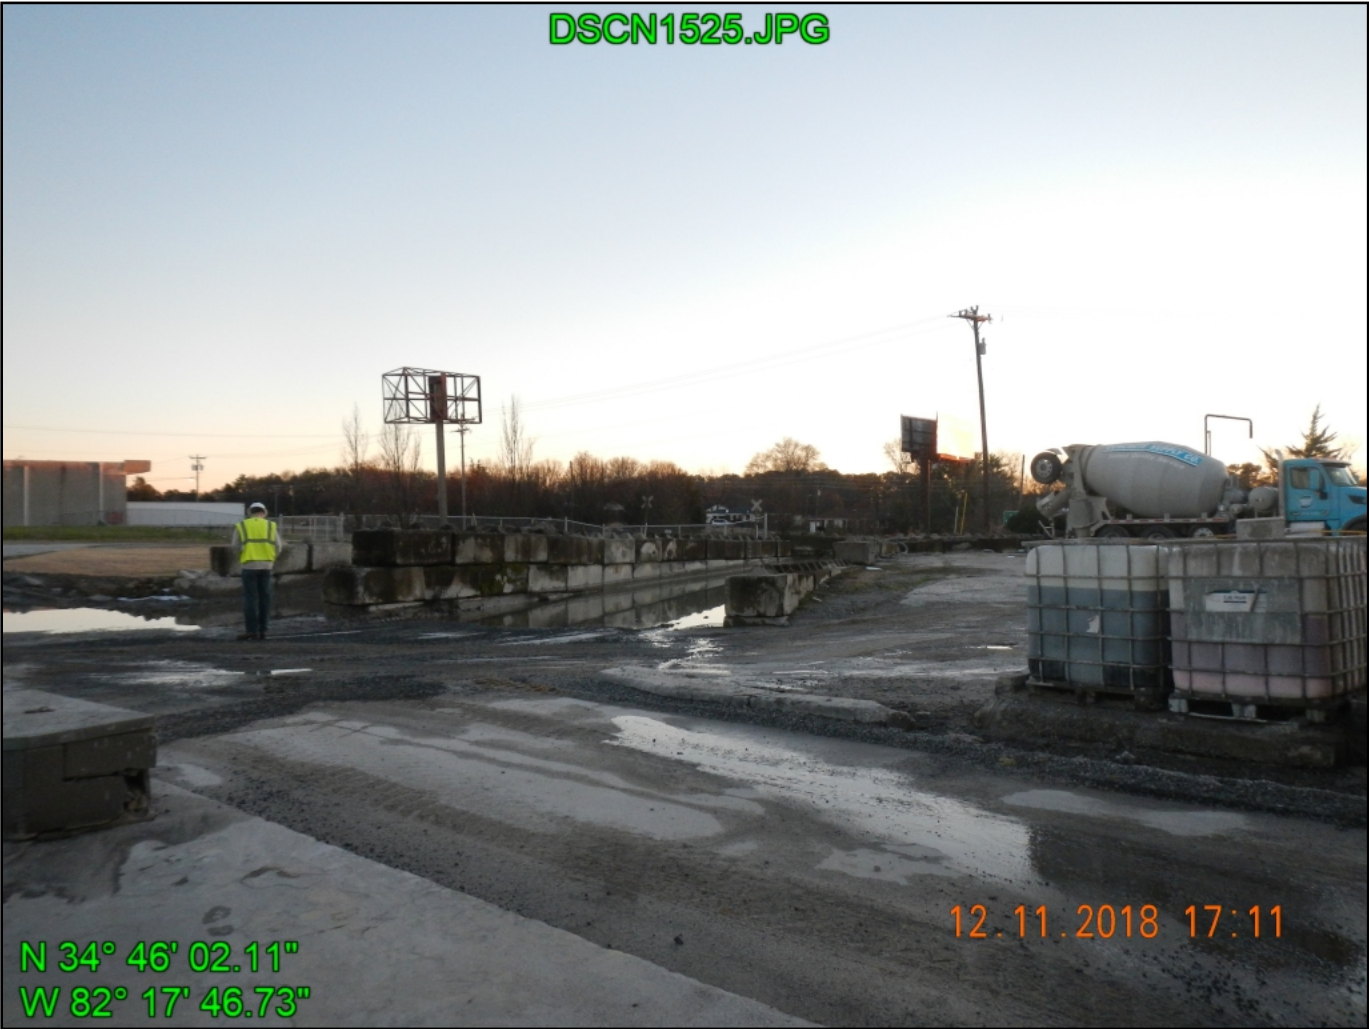
Attributes	
Description	Recycled water basin at left-center, and truck washdown station foreground and right.

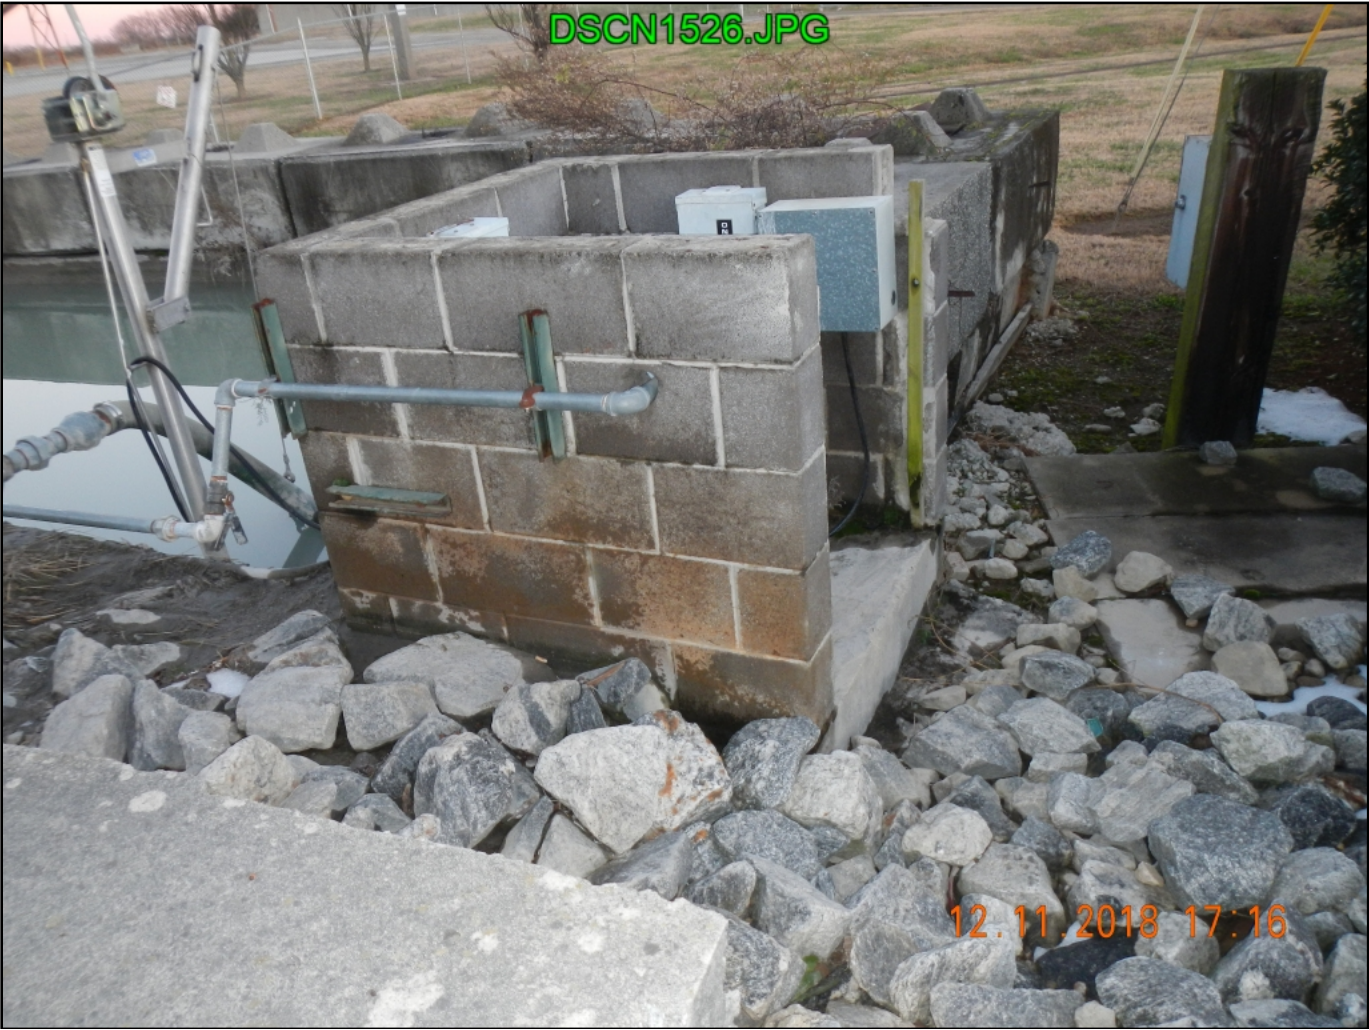
Attributes	
Description	Pump station in water recycling area. The holding basin had 3 inches of freeboard and evidence of past overflows.

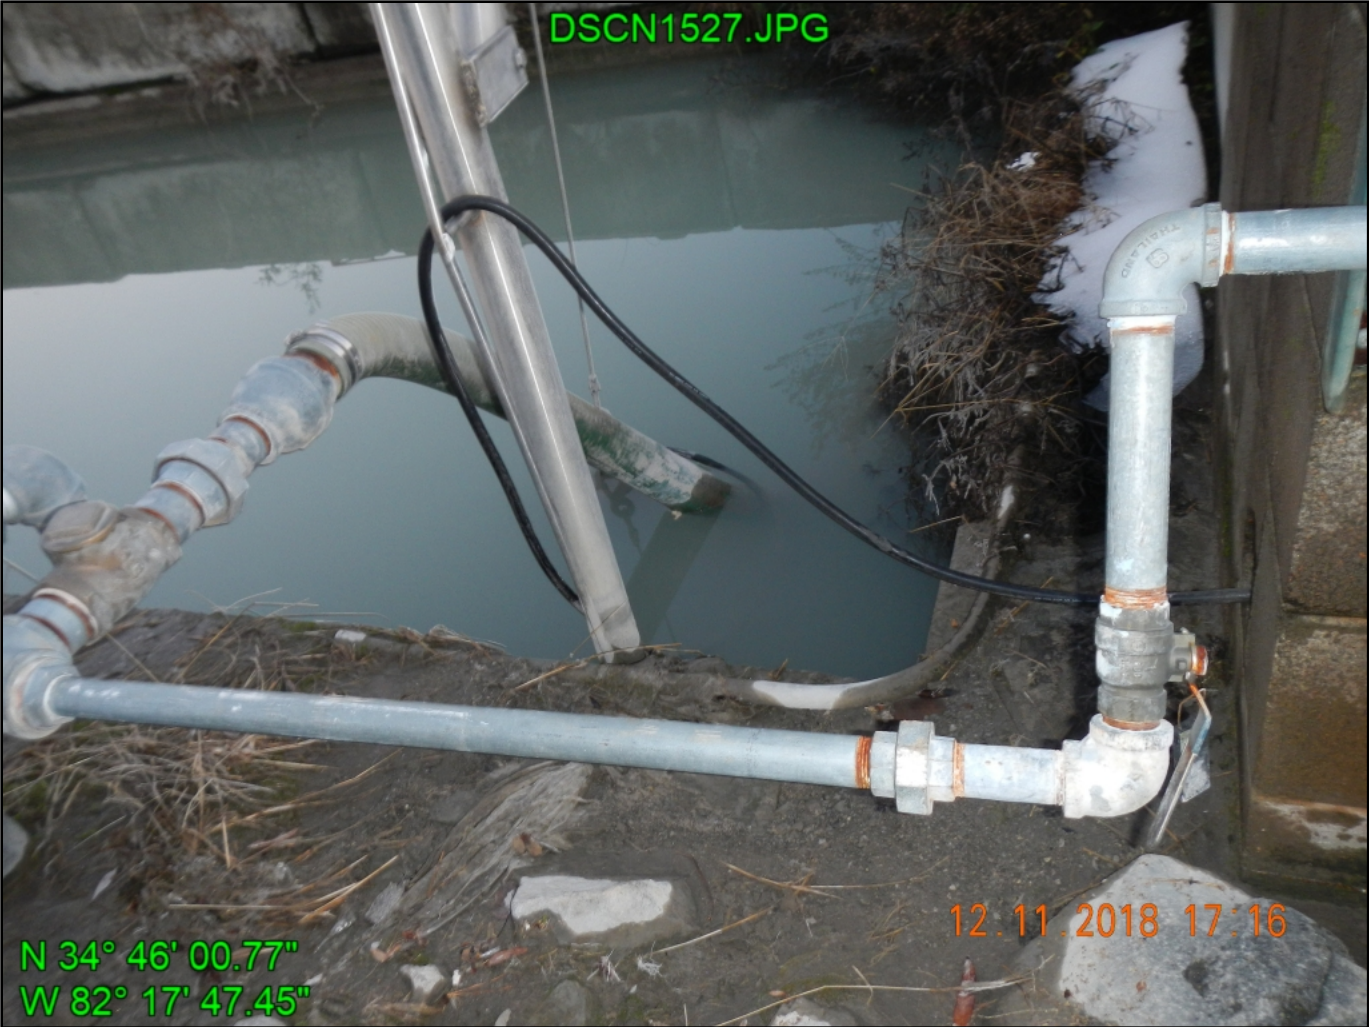
Attributes	
Description	A closer view of the inlet side of water pump equipment at the recycle water basin. Water level is about 3 inches from overflowing.

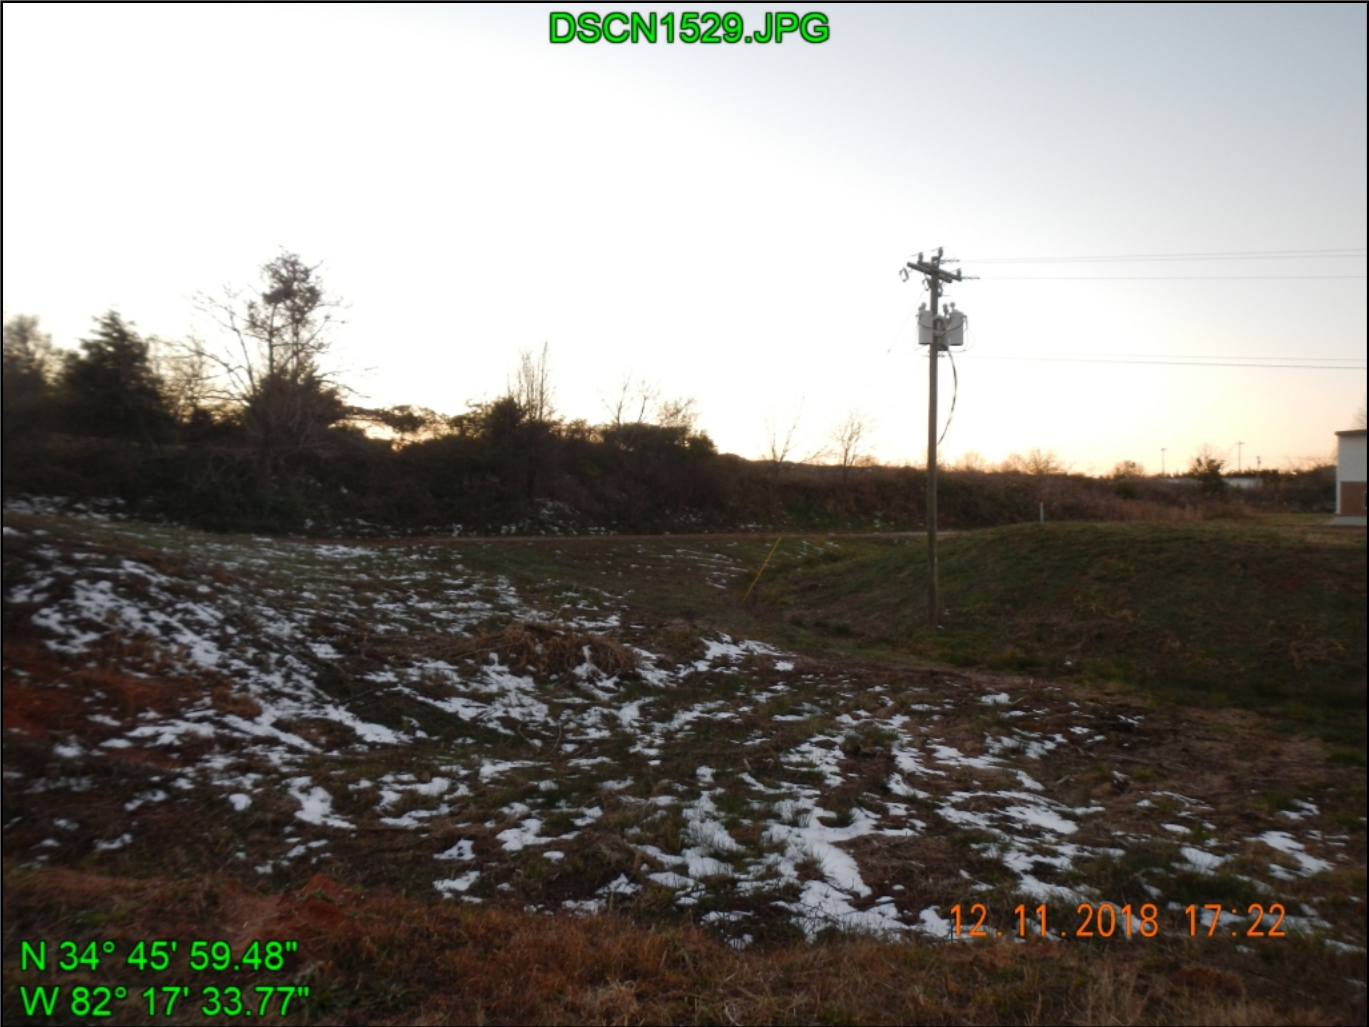
Attributes	
Description	Water from the area of the berm surrounding the concrete recycle area (horizon/background center-right) flows towards the photographer.

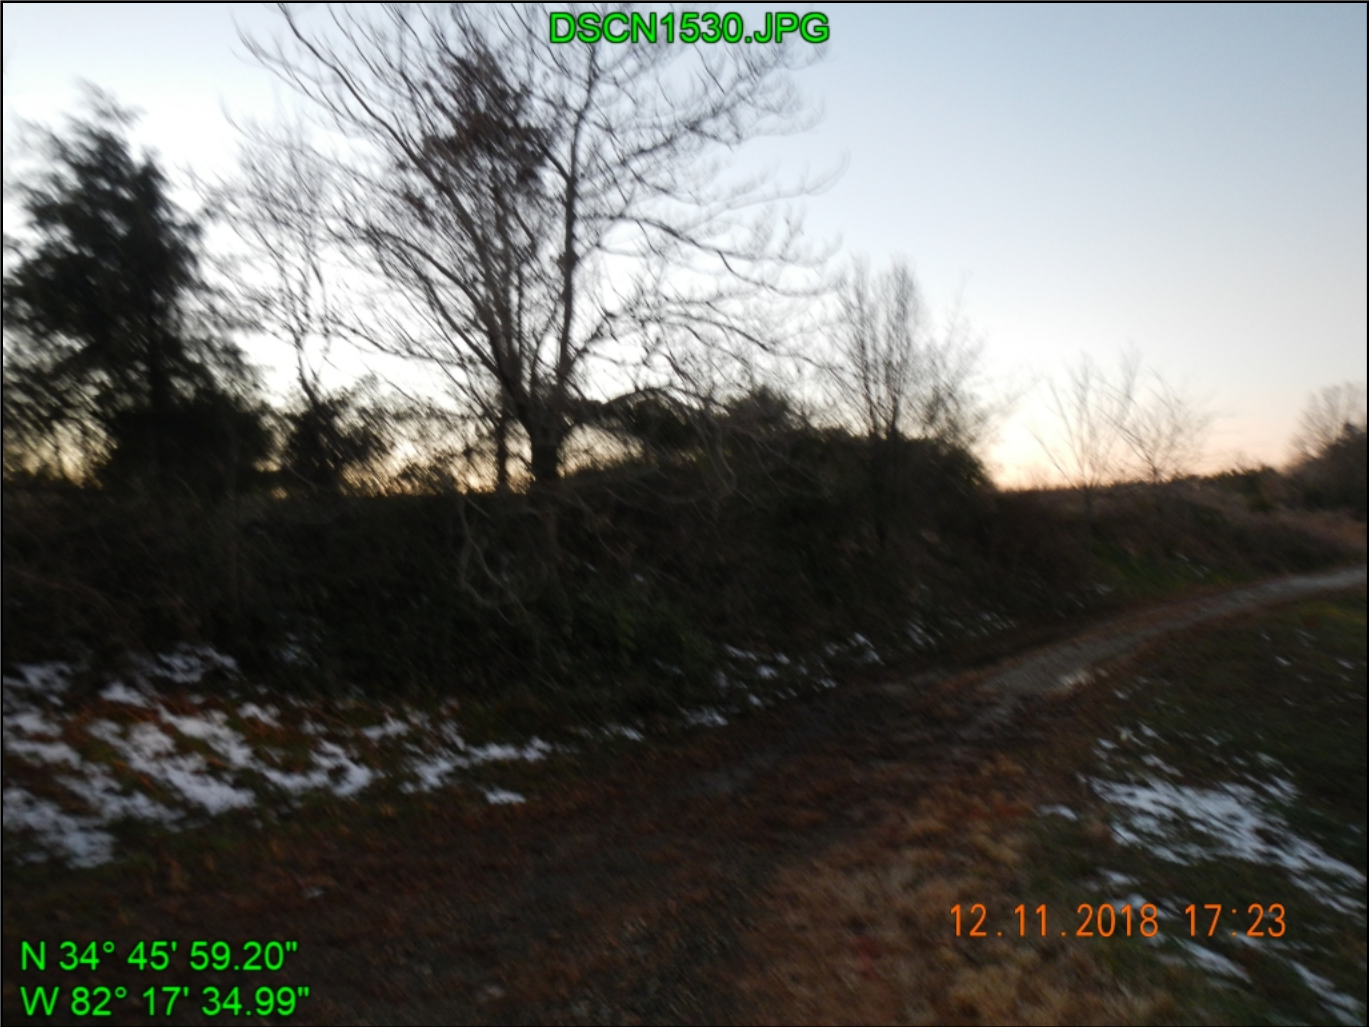
Attributes	
Description	Stormwater conveyance behind recycled concrete area berm.

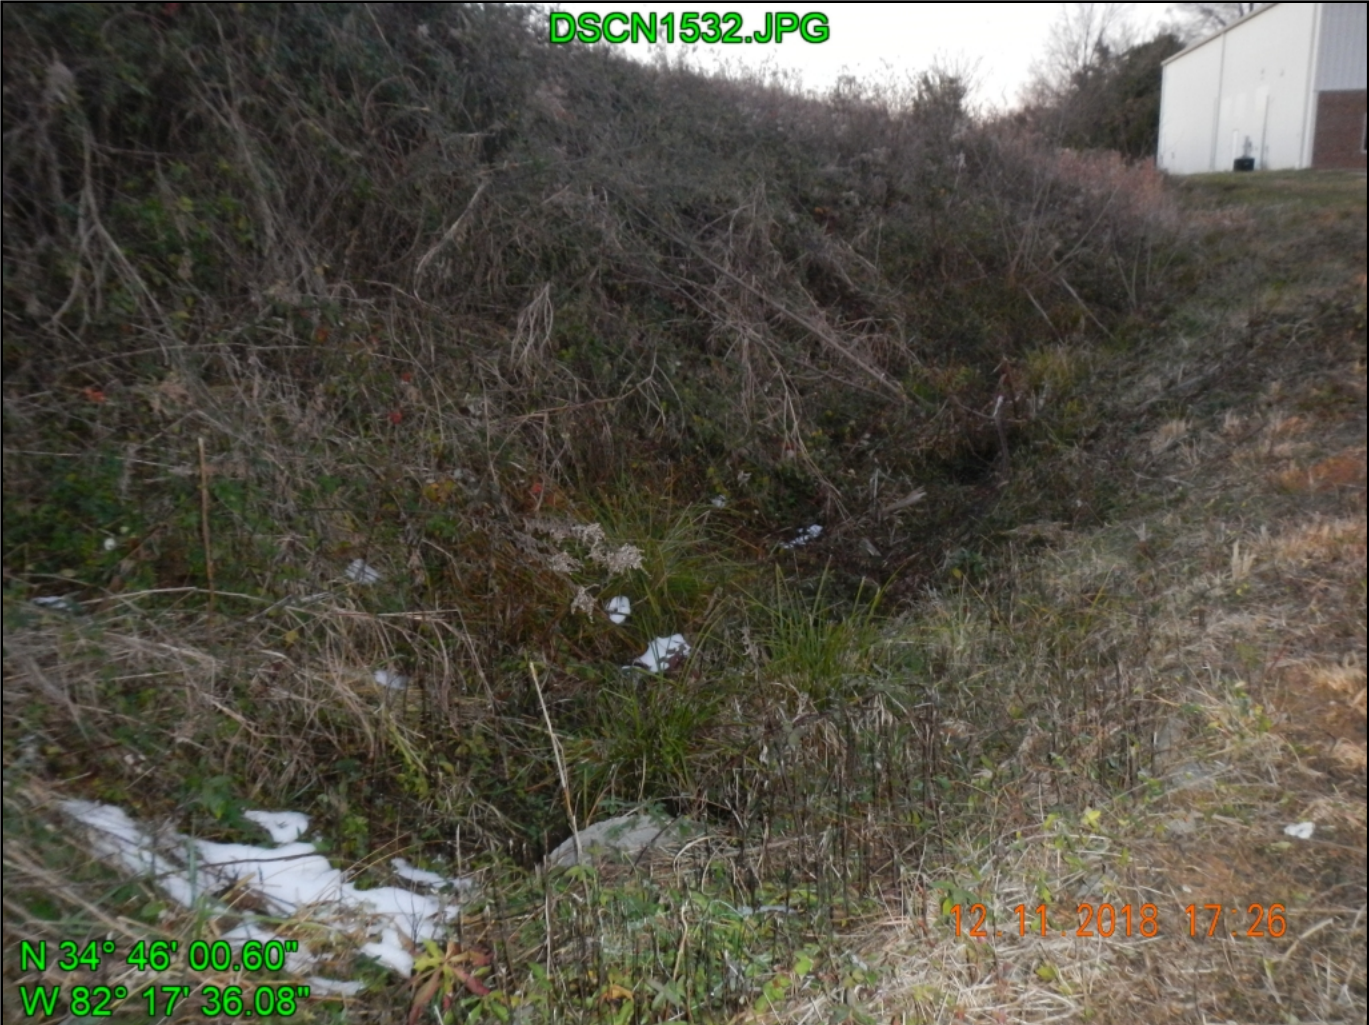
Attributes	
Description	In the foreground is the inlet side of a pipe under the access road. It receives water from the northwestern side of the facility, including from the outlet area of Outfall #3 and the seeps from the berm around the concrete recycling area.

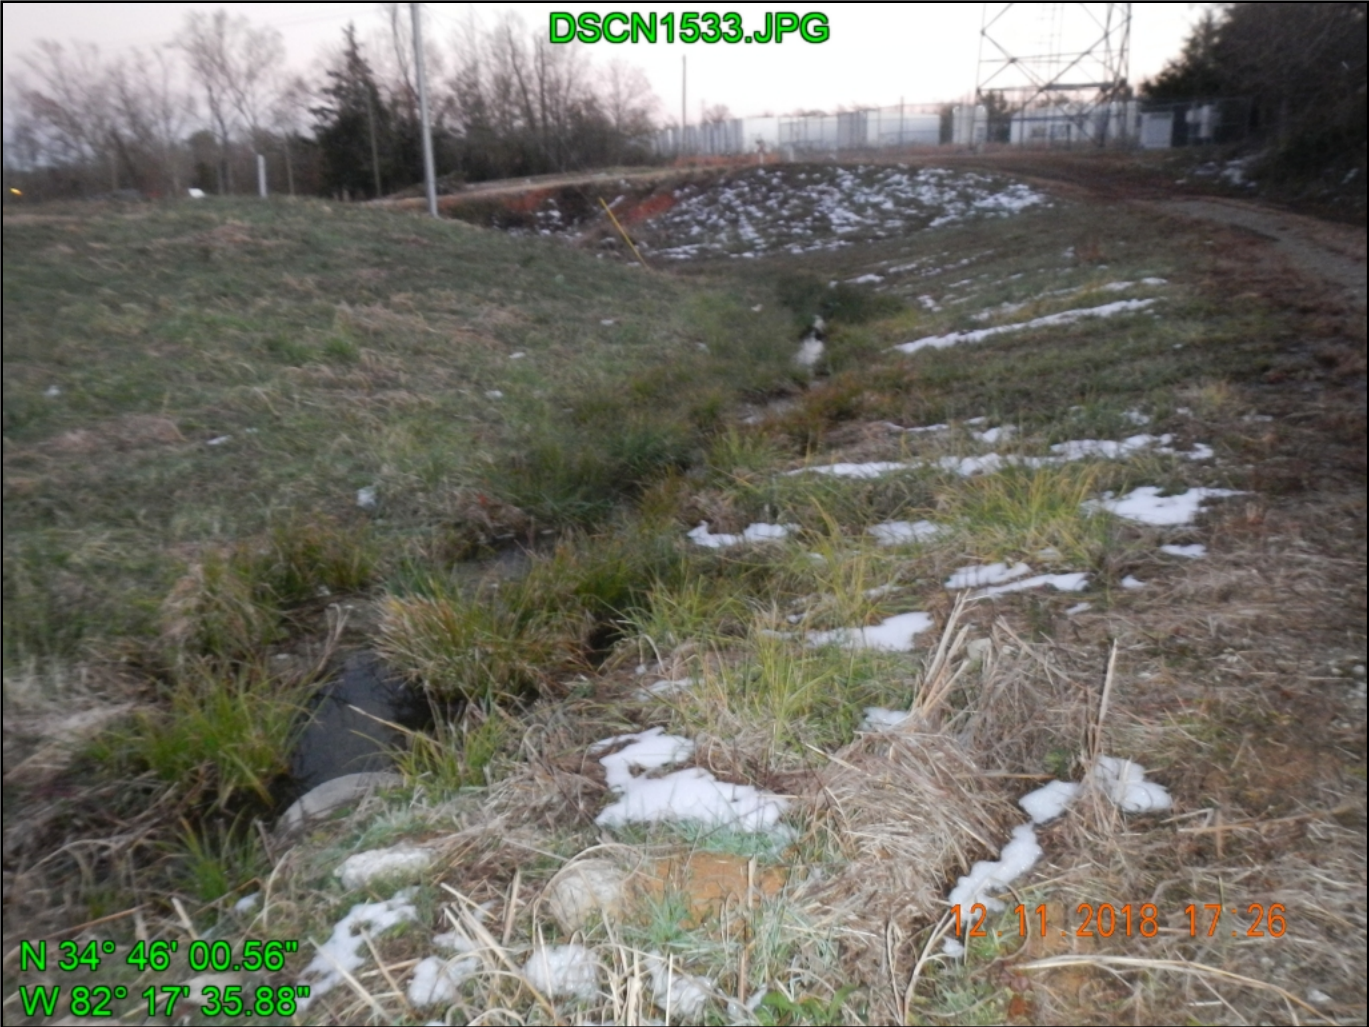
Attributes	
Description	Outlet side of the pipe under the road that handles runoff from this side of the site. This conveyance is next to the cell tower access road. Water was observed flowing through this conveyance.

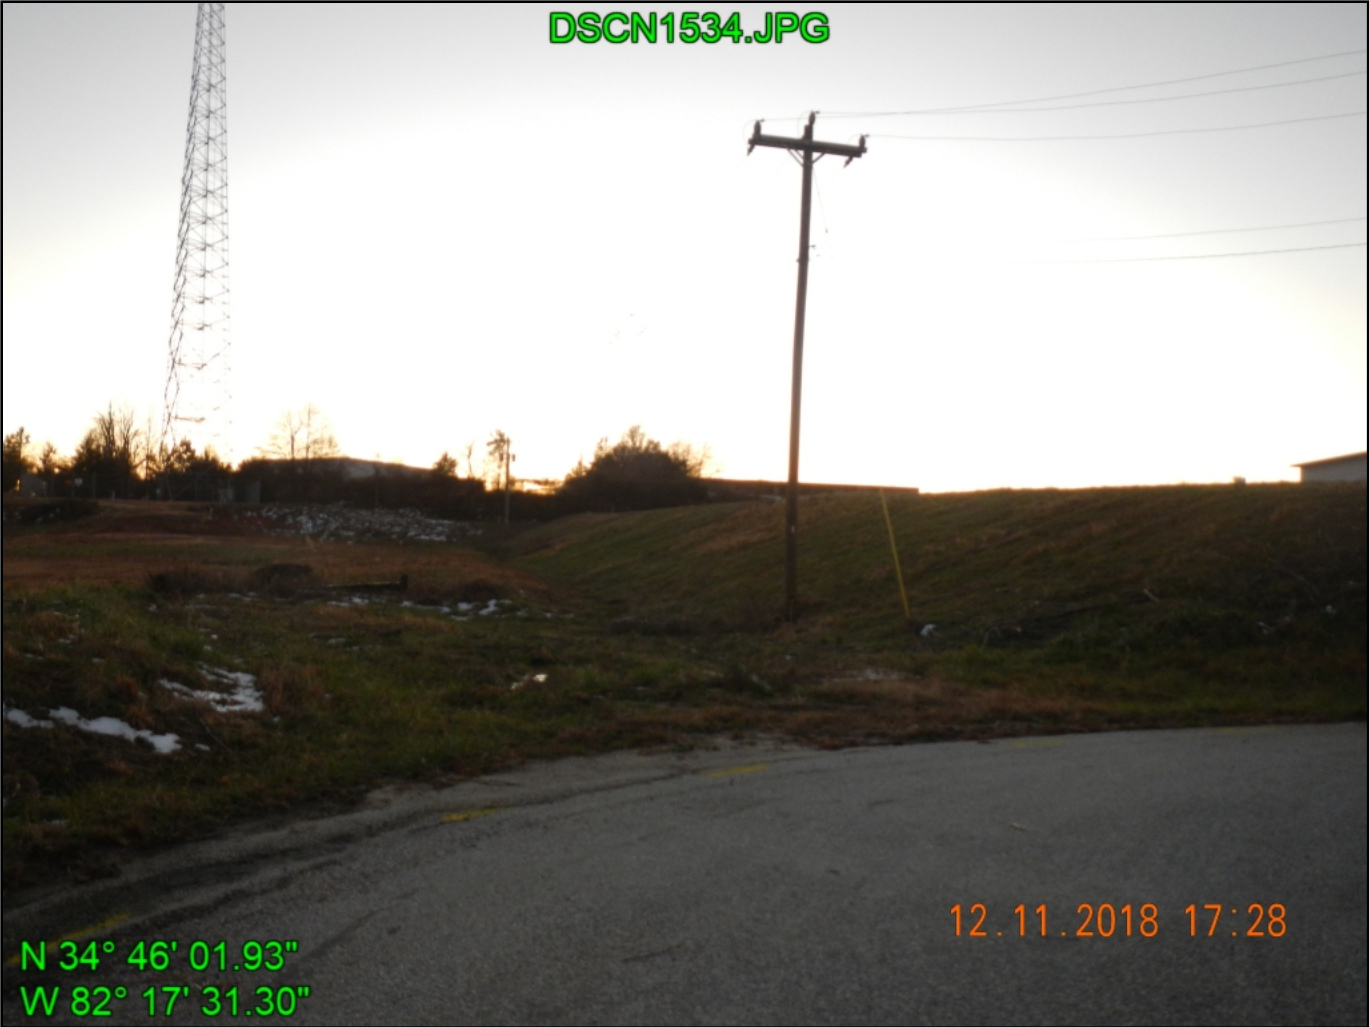
Attributes	
Description	Drop inlet downgradient from the pipe in photos DSCN1532 and DSCN1533.
